Report Number:	20180616FE CR Code 4 1639		
Location:		Insp Date:	3/27/2018
GPS:	-25.82325 28.26212	Rep. Date:	6/22/2018
Asset ID:	AP76475	ISN:	000
Asset Obs:	Poly Termination	Voltage:	35KV
		Phase:	L1
Repair Code:		Rating:	C

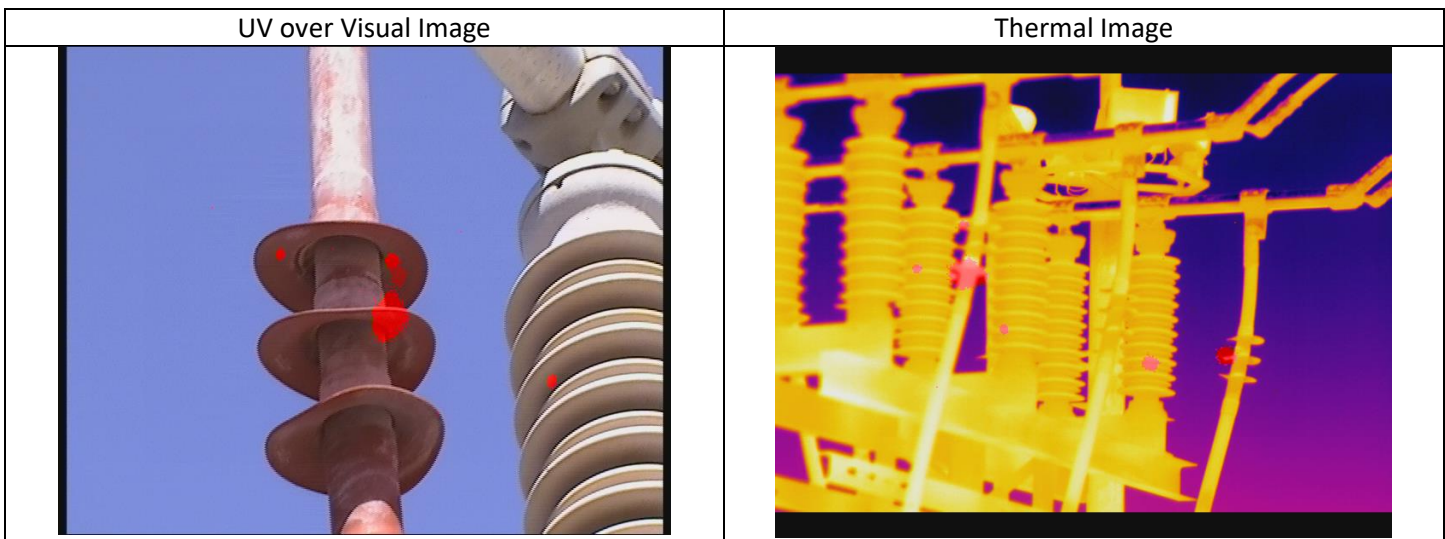
Discharge observed from termination insulator shed. Hot spot co-witnessed.

No contamination observed

Arcing activity from deteriorated or damaged terminations.

Repair at the earliest convenience.
