Report Number:	20180616FE CR Code 4 1639		
Location:	PGCIL	Insp Date:	9/15/2018
GPS:		Rep. Date:	
Asset ID:	52668674567	ISN:	4
Asset Obs:	Line space on incoming side	Voltage:	400 kV
		Phase:	All
Repair Code:	B2348	Rating:	B

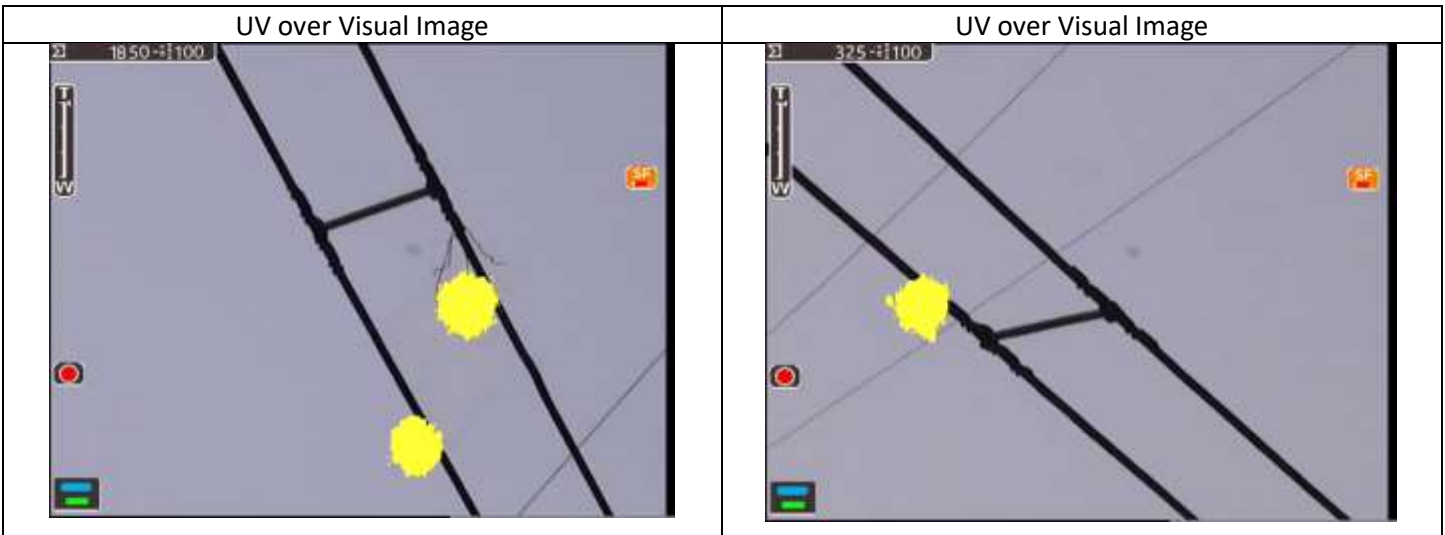
Discharge from line spacer armor rod

1x armor rod can be seen to be fraying. The rest are due to the armor rod not being finished correctly.

Discharge is not directly damaging anything, but the fraying may indicate a future failure. If the discharge co-locates with a hotspot then there may be internal arcing activity in the loosened armor rod.

Wait for next shutdown and correctly finish off the armor rod. Alternately replace the line spacer.
